**The analysis of hydraulic tests of pipes with defects, reinforced with composite bandage.**

**Task 4.2 (E. O. PATON EWI): To produce a full-scale pipe specimen with the composite wrap over artificial VSD. The specimen will be prepared according to the input data from WP3, experimental data from Task 4.1 and taking into consideration the requirements of ISO/TS 24817.**

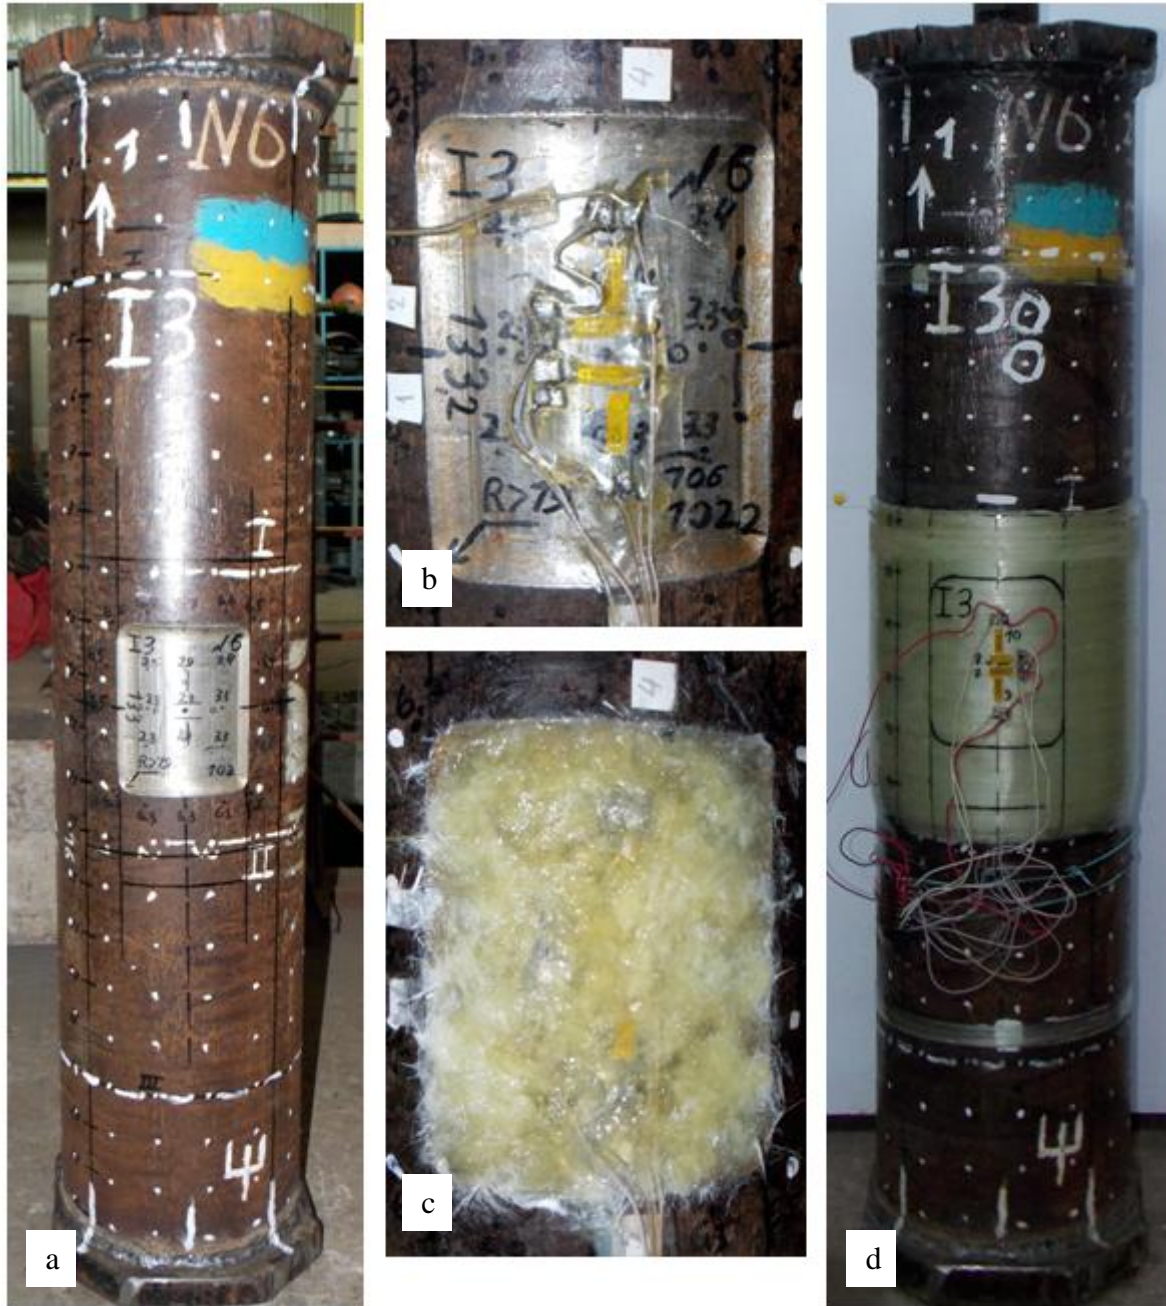
Fig. 1. Preparing a full-scale model.  
*a - prior to installation of strain gages and bandage; b - installation of strain gages in the defect; c - the defect filled with strain gages compound, d - sample with the bandage and strain gages.*

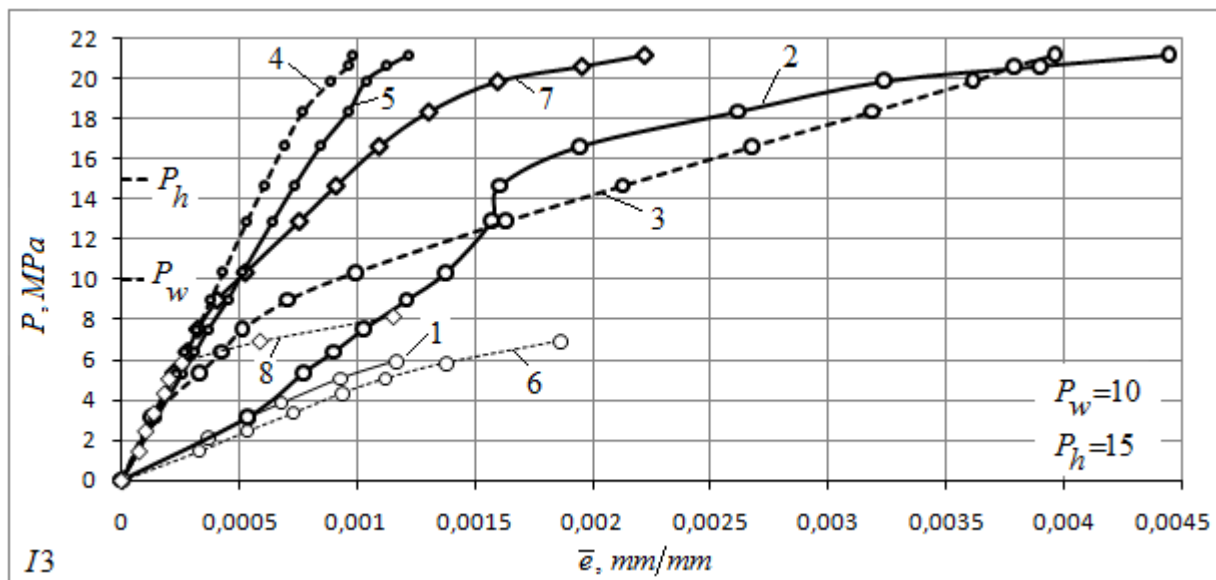
Fig. 2. The deformation of the sample during the initial stages of loading.

Fig. 2 shows the results of measurement of the deformations of the pipe in the defect area and the regular area, before installing the bandage, and after its installation. Loading without bandage was held up to the pressure at which there appeared permanent deformation in the defect in the annular direction. The figure also shows the deformation of the bandage. For comparison, Fig. 2 shows a similar deformation of the sample (of the same pipe and the same defect), but which is tested without installation of the bandage.

Ring strain: 1 - in the defect prior to installation of the bandage, 2 - after; 3 - bandage in the defect area, 4 - in the regular area; 5 - the pipes in a regular zone; 6 - in the defect of the similar sample. Axial deformations: 7 - in the defect after installation of the bandage; 8 - in the defect of similar pattern.  $P_w$ ,  $P_h$  - accepted working and test pressure.

Installing the bandage on the sample had no effect on the initial part of axial strain in the defect, which also coincides with the same area of the sample with defect and without a bandage. Axial deformation of the bandage over the defect coincide with the axial deformations of the defect. When deformation of  $\sim 0.1\%$  the sensor has failed in all probability because of cracking. After installation of the bandage circumferential deformation in the pipe were slightly decreased. The dependence of the circumferential deformations of the regular part of the pipe from the pressure in Fig. 2 is not representative because the strain gages were installed in the local place, and their indications are very influenced by the ovality of the pipe.

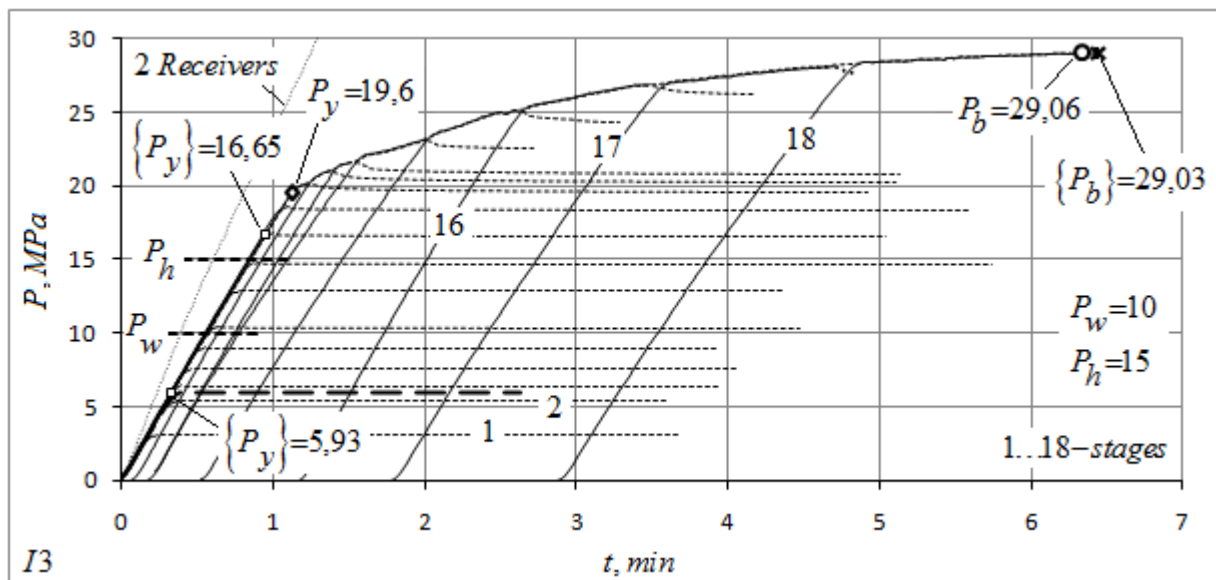
Fig. 3. The diagram of loading of the sample with internal pressure to destruction.

$P_w$ ,  $P_h$  - accepted working and test pressure;  $\{P_y\}$  - total yield stress defined by an annular strain gages in the defect;  $P_y$  - total yield stress defined as the breaking point of the diagram of loading by internal pressure;  $P_b$ ,  $\{P_b\}$  - the maximum pressure that the sample sustained, and the pressure at which the destruction occurred; 2 Receivers - chart of loading of two paired receivers without test object; thick dashed line - the last (5th) stage before installation of the bandage; thin dashed lines - shutter speed on the stages.

Fig. 3 shows that the pressure at which a residual deformation in the circumferential direction of the defect after the installation of the bandage begin to appear, significantly increased from 5,93 up to 16,55 MPa, which is higher than the test pressure. The same pressure, but for the sample tested without a bandage until the destruction amounted to 5.83 MPa.

Maximum pressure that withstood a sample made of the same pipe, but with no defect and bandage amounted to 27.59 MPa, hence it can be concluded that the bandage fully restored carrying capacity of the pipe with a defect. For example, the actual burst pressure of sample with defect and without bandage amounted to 13.83 MPa.

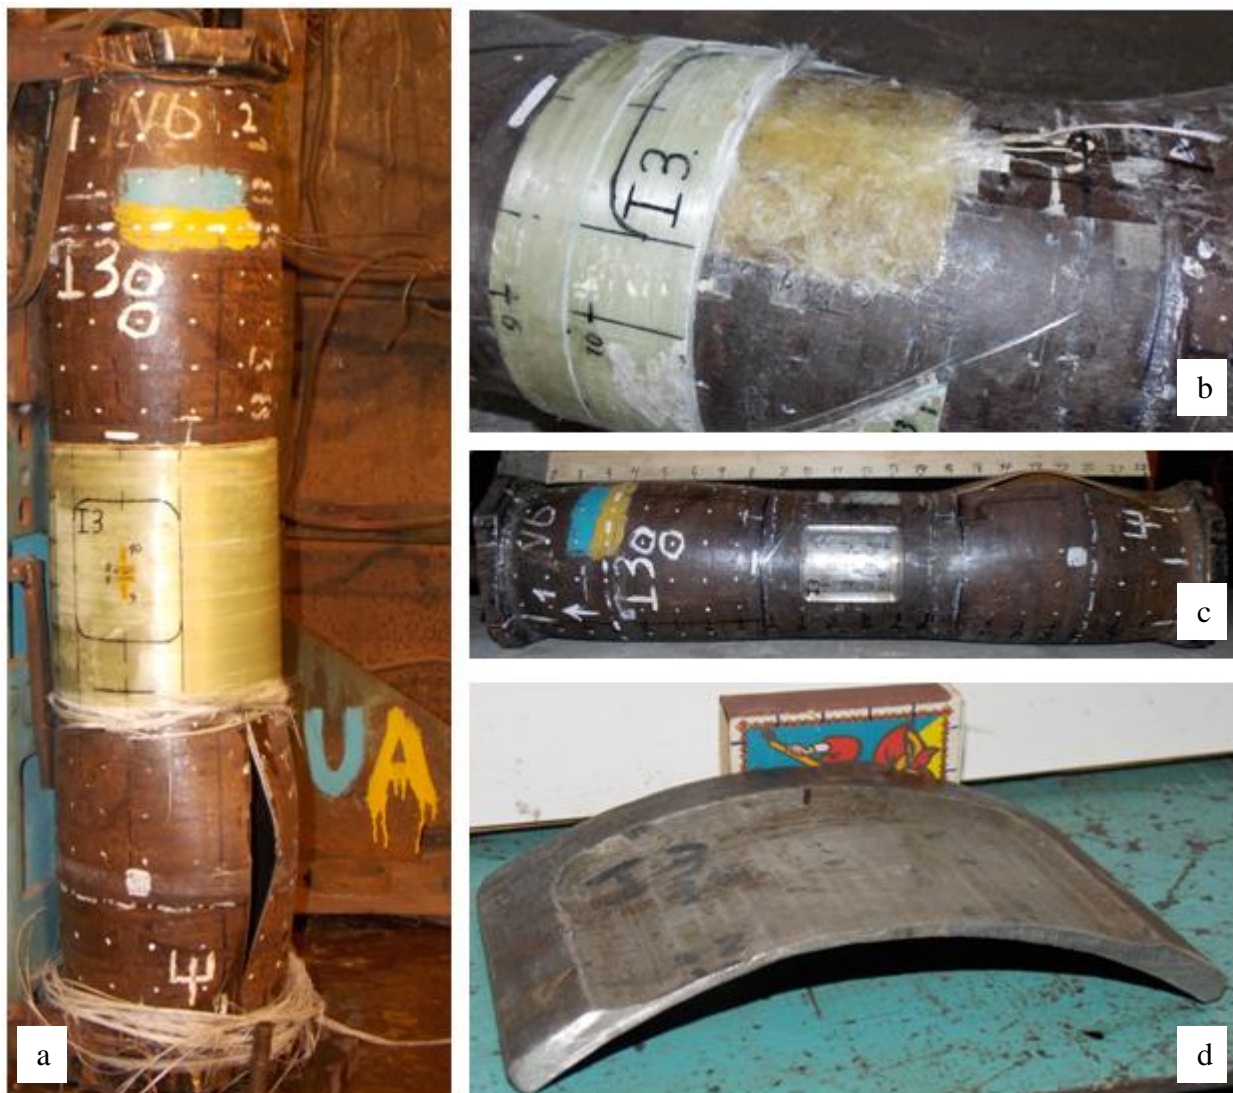
Fig. 4. The sample after the test.

Figure 4 shows the full-scale sample after the testing with internal hydraulic pressure until destruction. The destruction took place on the pipe section not covered with the bandage. In accordance with the requirements to the surface of the fracture and form a line of depressurization, by pressure tests to destruction as specified in [10], and given the lack of debris, the collapsed sample was viscous.

*a - sample after destruction by hydraulic pressure; b - opening of the defect; c - after removal of bandage; d - cut part of the defect.*

The ultimate deformation at which there is a destruction of the bandage, is 1.4 %. After removing the bandage, circumferential residual strain in the defect was 1.33 %, which shows that the bandage in the area of the defect was close to its limit state. Residual circumferential

deformation of defect-free sample area covered by the bandage was ~ 0.2% and uncovered the bandage ~ 11 %. Note that after destruction the residual circumferential deformation in the defect when testing a similar sample, but without bandage was 5.2 %.
