DEVELOPMENT OF AN EXPERIMENTAL PROGRAMME AIMED AT EMPHASIZING THE CONSOLIDATION EFFECTS OF COMPOSITE MATERIAL WRAPS APPLIED FOR THE REPAIR OF TRANSMISSION PIPELINES WITH VOLUMETRIC SURFACE DEFECTS

Prof. dr. eng. Gh. Zecheru¹, Dr. eng. P. Yukymets², Assoc. Prof. dr. eng. A. Dumitrescu¹, Eng. R. Dmitrienko²
 Petroleum-Gas University of Ploiesti, Romania¹, E.O. Paton Electric Welding Institute of the National Academy of Ukraine, Kiev²
 E-mail: gzecheru@upg-ploiesti.ro; yupiter@ukr.net; andrei_d@upg-ploiesti.ro; dril1@ukr.net

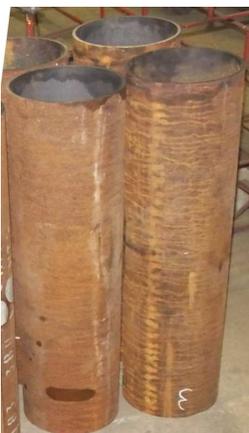
Fig. 13. Blank pipes used for specimens

Applying equations (1-3) for the PRCI pipes (with the defect dimensions shown in Figure 11) and then for our pipes, we have obtained the following defect dimensions values: $s_p = 133$ mm; $c_p = 103$ mm; $d = 2.4, 3.6, 4.5$ mm. The pipes used as specimens are shown in Figure 13 before machining the VSDs and in Figure 14 after machining the defects. The specimen geometry will be the same as the one used by PRCI (Figure 11).

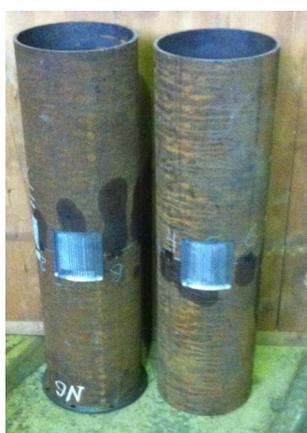
Fig. 14. Defects machined on two specimens
